Visual Inspection Property Report (VIPReport) A1 Appraisal Service P.O. Box 871452 Vancouver, WA 98687-1452

Re: Property: 10102 NE 11th St

<u>Visual Inspection Property Report - Property Information</u>

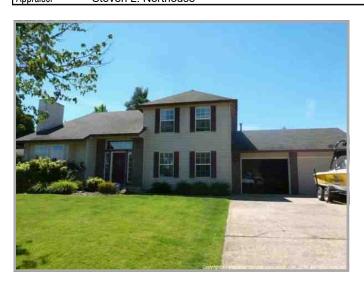
Front; Hardi Plank Siding, vinyl windows and composite roof

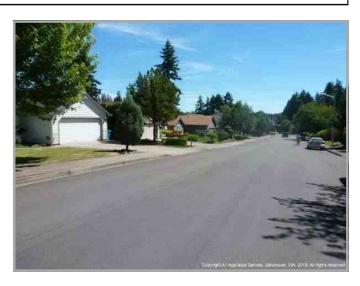
Street; Asfault with curbs and sidewalks

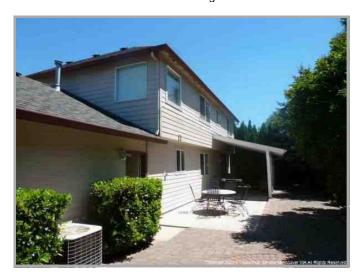
Rear; A/C unit, Patio(s), wood rear fenced. View - fence/trees Rear Covered Patio

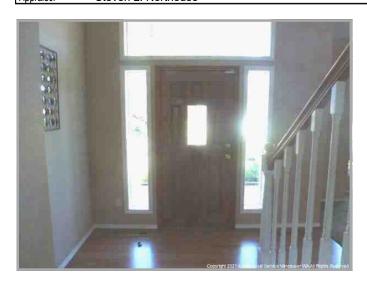
Interior Front Entry; wood laminate flooring

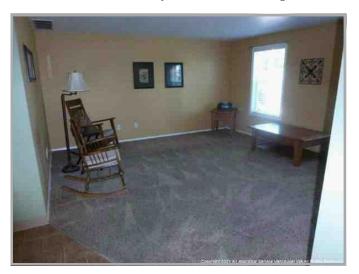
Family Room; carpet flooring

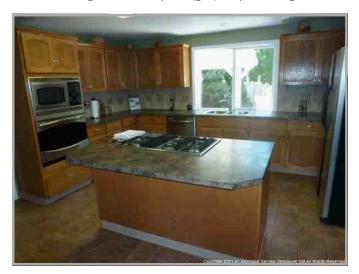
Kitchen; laminate countertops, wood cabinets and vinyl flooring

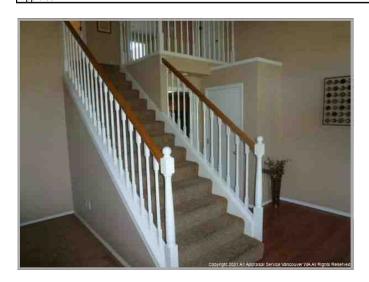
Stairs to 2nd Floor, carpet

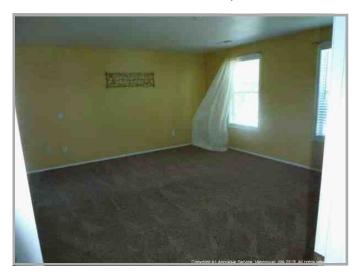
Primary Bedroom; carpet flooring and walk-in closet

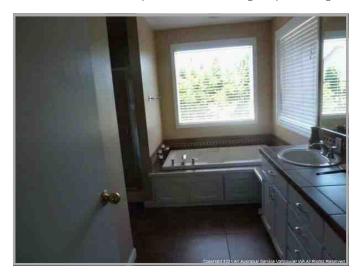
Primary Full Bath; tile countertops, tile flooring, jetted tub

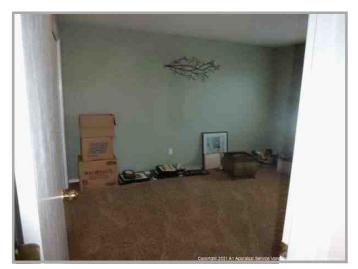
Bedroom2; carpet flooring and closet

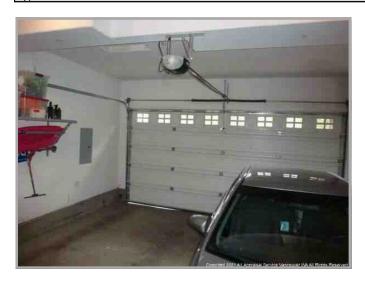
Two-Car Garage, door opener with safety sensors, finished

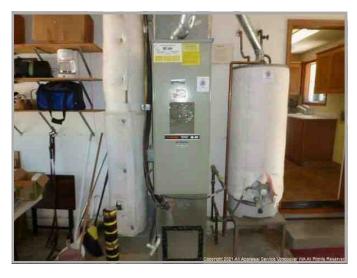
Garage Interior: Two-car garage with a gas furnace and a gas hot water tank. Both elevated from floor. No hot water tank strap. Interior access is from the laundry room. Exterior access, from the garage to the right side of the dwelling. Circuit breaker panel is located in garage. Interior walls are finished with drywall. There is a garage door opener with safety sensors.

Furnace (gas)/Hot Water (gas) (Location: Two-Car Garage)

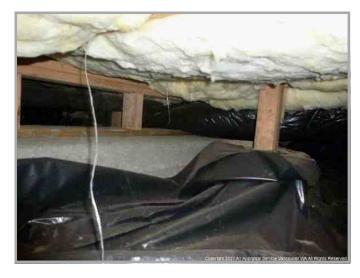
Crawlspace: Access is located from the main level closet near front entry. Head and shoulders inspection only. No observable water damage or standing water from the access. Water barrier (plastic tarp) present. Post/beams on concrete pads for each post/beam, remainder is dirt under tarp. Concrete foundation with no apparent damage observed.

Crawlspace (head and shoulders observation only), see comment

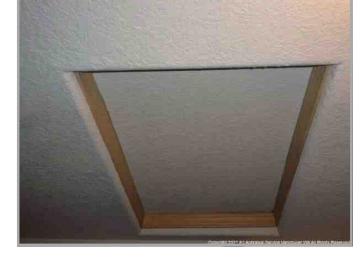
Attic/Scuttle: Access is located from the Primary Bedroom Closet. Head and shoulders inspection only. From the access, no observable water damage, or leaks (discoloring of wood on underside of roof), insulation was observed from the access.

Attic/Scuttle Access (Primary Bedroom Closet ceiling)
